DEPARTMENT OF TRANSPORTATION

Contract #: 04-0120F4Cty: SF/ALA Rte: 80 PM: 13.2/13.9File #: 99.28**WELDING INSPECTION REPORT****Resident Engineer:**Siegenthaler, Peter**Address:** 333 Burma Road**City:** Oakland, CA 94607**Report No:** WIR-018305**Date Inspected:** 27-Nov-2010**Project Name:** SAS Superstructure**OSM Arrival Time:** 700**Prime Contractor:** American Bridge/Fluor Enterprises, a JV**OSM Departure Time:** 1900**Contractor:** Zhenhua Port Machinery Company, Ltd (ZPMC)**Location:** Shanghai, China**CWI Name:** Li Yang and Zhu Zhong Hai**CWI Present:** Yes No**Inspected CWI report:** Yes No N/A**Rod Oven in Use:** Yes No N/A**Electrode to specification:** Yes No N/A**Weld Procedures Followed:** Yes No N/A**Qualified Welders:** Yes No N/A**Verified Joint Fit-up:** Yes No N/A**Approved Drawings:** Yes No N/A**Approved WPS:** Yes No N/A**Delayed / Cancelled:** Yes No N/A**Bridge No:** 34-0006**Component:** OBG Trial Assembly**Summary of Items Observed:**

WELDING INSPECTION REPORT

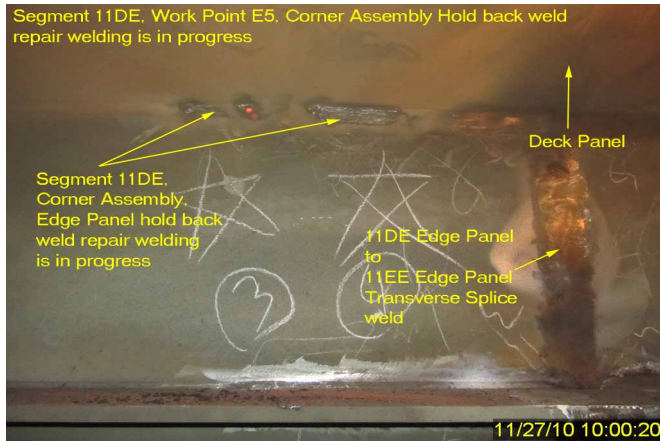
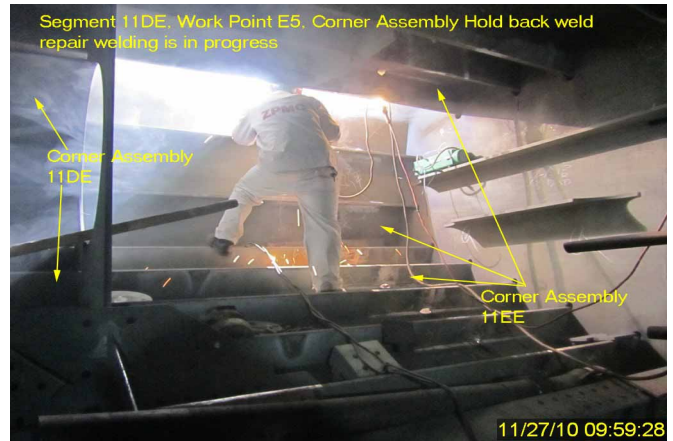
This QA Inspector observed the repair welding by Shielded Metal Arc Welding (SMAW) process on a Complete Joint Penetration (CJP) groove weld. The Weld joint was designated as CA093-002. The welder identification was 040320 and was observed welding in the 4G (Overhead) position using approved Welding Procedure Specification WPS-345-SMAW-4G(4F)-FCM-Repair-1. The piece mark was identified as Edge Panel to Deck Panel hold back weld at work point E5. ZPMC performed repair welding in accordance with Welding Repair Report B-WR17822.

Please reference the pictures attached for more comprehensive details.

This QA Inspector observed the repair welding by Shielded Metal Arc Welding (SMAW) process on a Complete Joint Penetration (CJP) groove weld. The Weld joint was designated as Seg072-049. The welder identification was 040320 and was observed welding in the 4G (Overhead) position using approved Welding Procedure Specification WPS-345-SMAW-4G(4F)-FCM-Repair-1. The piece mark was identified as Edge Panel to Deck Panel hold back weld at work point E5. ZPMC performed repair welding in accordance with Welding Repair Report B-WR17822.

This QA Inspector observed the repair welding by Shielded Metal Arc Welding (SMAW) process on a Complete Joint Penetration (CJP) groove weld. The Weld joint was designated as Seg072A-044. The welder identification was 056289 and was observed welding in the 1G (Flat) position using approved Welding Procedure Specification WPS-345-SMAW-1G(1F)-FCM-Repair-1. The piece mark was identified as Side Panel to Bottom Panel hold back weld at work point E3. ZPMC performed repair welding in accordance with Welding Repair Report B-WR17823.

This QA Inspector observed the repair welding by Shielded Metal Arc Welding (SMAW) process on a Complete Joint Penetration (CJP) groove weld. The Weld joint was designated as Seg074A-014. The welder identification

was 056289 and was observed welding in the 1G (Flat) position using approved Welding Procedure Specification WPS-345-SMAW-1G(1F)-FCM-Repair-1. The piece mark was identified as Side Panel to Bottom Panel hold back weld at work point E3. ZPMC performed repair welding in accordance with Welding Repair Report B-WR17823.
